## Agricultural Spray Inspection According to ISO 16122

Alfran Tellechea Martini<sup>1</sup>, José Fernando Schlosser<sup>1</sup>, Emilio Gil<sup>2</sup>, Marcelo Silveira de Farias<sup>1</sup>,  
Gilvan Moisés Bertollo<sup>1</sup>, Luis Fernando Vargas de Oliveira<sup>1</sup> & Giacomo Müller Negri<sup>1</sup>

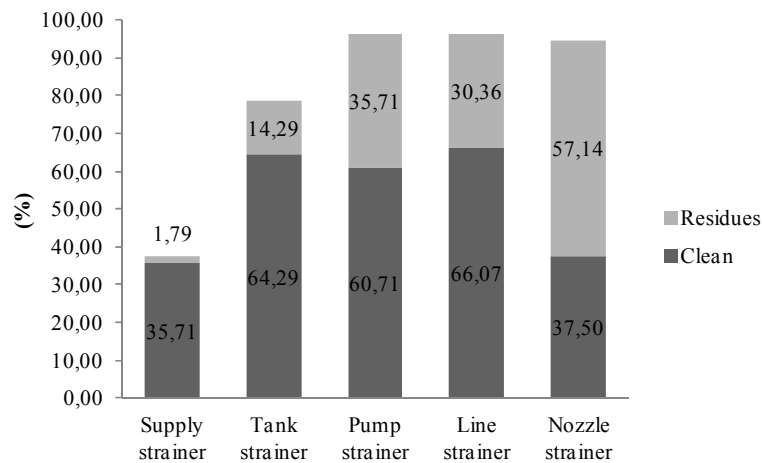
Figure 1. Sprayer distribution (clean and with residues for each item evaluated)

As for the tank strainer, it was present in 89.28% of the strainers; it was damaged in 10.71%. Only 64.29% did not contain residues, as shown in Figure 1. The pump strainer was present in 96.43% of the strainers; 35.71% of them contained residues.

Regarding line strainers and nozzle strainers, it was observed that they were absent in, respectively 3.57% and 5.36% of the strainers (Table 3). Nevertheless, of the total amount that was deemed to be in good conditions, 30.36% contained residues, as Figure 1 shows. Similar results were obtained by Baldi and Vieri (1992), which observed that, in Italy, 36.00% of the inspected sprayers had no line strainer, were damaged, or contained residues.

The situation was worse for nozzle strainers: 57.14% of the samples contained residues. Residues were not the only reason for rejection; in 26.79%, besides residues, it was also observed the use of distinct strainers, which may occasion problems in the nozzles (flow reduction and early wear), as well as in the distribution of the solution, since there is a difference in the number of meshes by square inch, thus affecting the efficiency of the straining system.

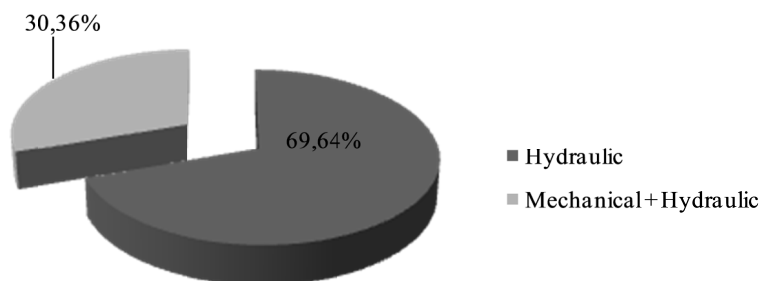
Figure 2. Category division referring to agitators present in the sprayers inspected

This evaluation showed that 100% of the sprayers were approved as to the presence of the agitator. However, 69.64% of the sprayers presented only the hydraulic system as agitator, which entailed a return of the repressed amount by the spray pump; only 30.36% of the sprayers presented some type of mechanical hydraulic agitation (Figure 2).
