Geophysical and Geotechnical Investigation of Road Pavement Failure in Part of Ibadan Metropolis Southwestern Nigeria

Case Study

Road pavement failure observed along a section of Apete-Akufo Major Road in Ibadan metropolis southwestern Nigeria, necessitates the need to ascertain whether the failure results from poor construction practices or poor engineering properties of subgrade materials. Geophysical and geotechnical survey results were compared to investigate the cause of the road pavement failure. Vertical Electrical Sounding (VES) with geotechnical study which include; grain size analysis, Atterberg limits and California Bearing Ratio (CBR) tests, were carried out on disturbed subgrade samples obtained between 0 – 1 m depth from VES Stations 1, 2 and 5, corresponding to unstable, stable and highly unstable sections of the road respectively. The quality of the subgrade was evaluated based on Atterberg limits, layer resistivity and CBR values. Eight (8) VES stations established 100m apart along the road section delineated 5 lithology; topsoil, clayey sand/lateritic clay, weathered bedrock and fresh bedrock with resistivity range of 68-238Ωm, 72-236Ωm, 224-859Ωm and 6720-15351

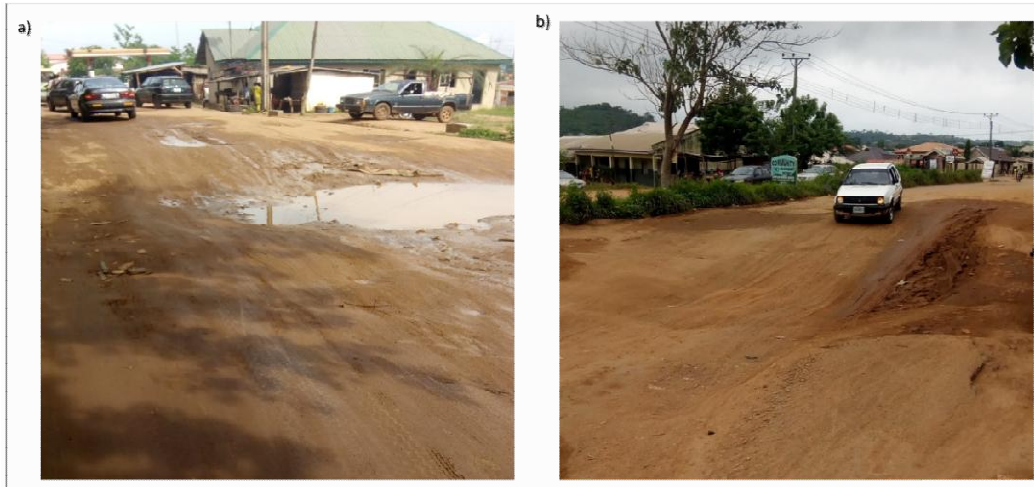
Fig. 1. a) Failed portion of the Apete-Akufo Road Southwestern Nigeria. (b) Failed portion of the Apete-Akufo road, with hills covered in vegetations showing in the background

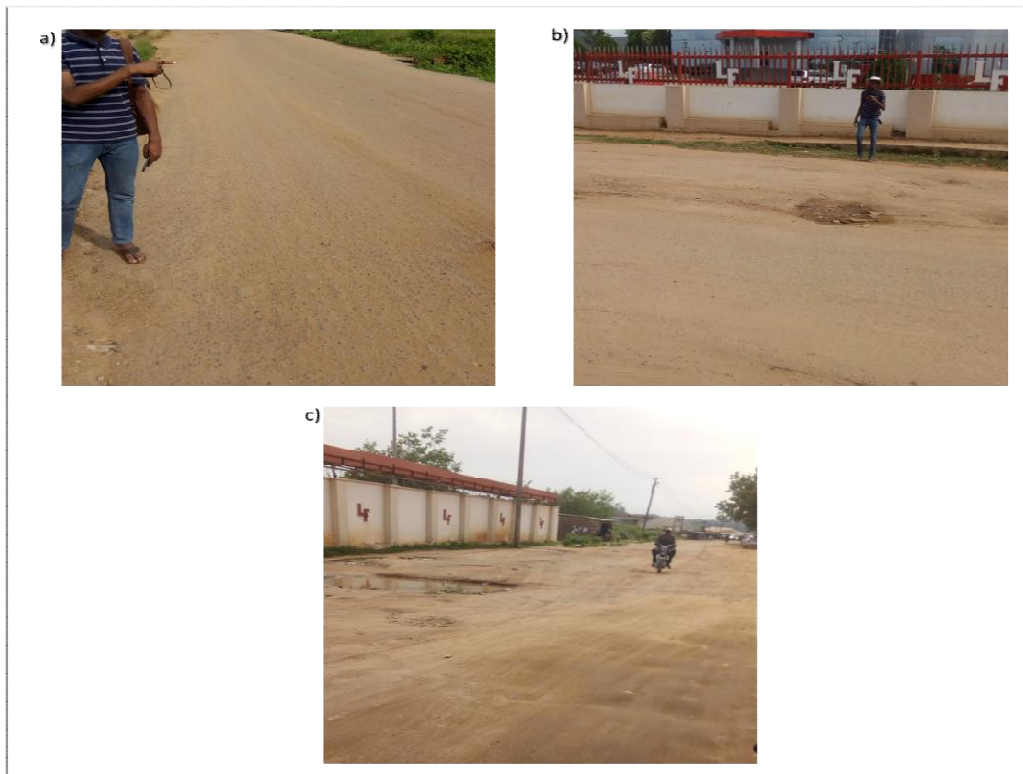
Initial analyses of results from field observation and geophysical measurement informed the categorization of the studied road pavement section into stable (presence of asphaltic road pavement), unstable (broken or mildly damaged asphaltic pavement), and highly unstable (no pavement with formation of trenches) sections (VES stations 2, 1 and 5 respectively) based on stability or degree of failure of available road pavement (Fig. 5).

Fig. 5. a) Stable (b) Unstable and (c) Highly Unstable sections of the Apete-Akufo road

Also, CBR results samples from VES Station 1 with soaked and unsoaked CBR of 11.41% and 70.14% respectively, indicate that the subgrade is fairly stable especially when the road is dry and its stability reduces with wetness. Hence the road pavement in this section failed due to poor drainage as observed on site. Samples from VES

Station 2 shows that the subgrade is stable when wet or dry with relatively similar soaked and unsoaked CBR values. Samples from the failed section in VES Station 5 has soaked and unsoaked CBR values well below acceptable standards and this can be said to be responsible for the failure of the road section.

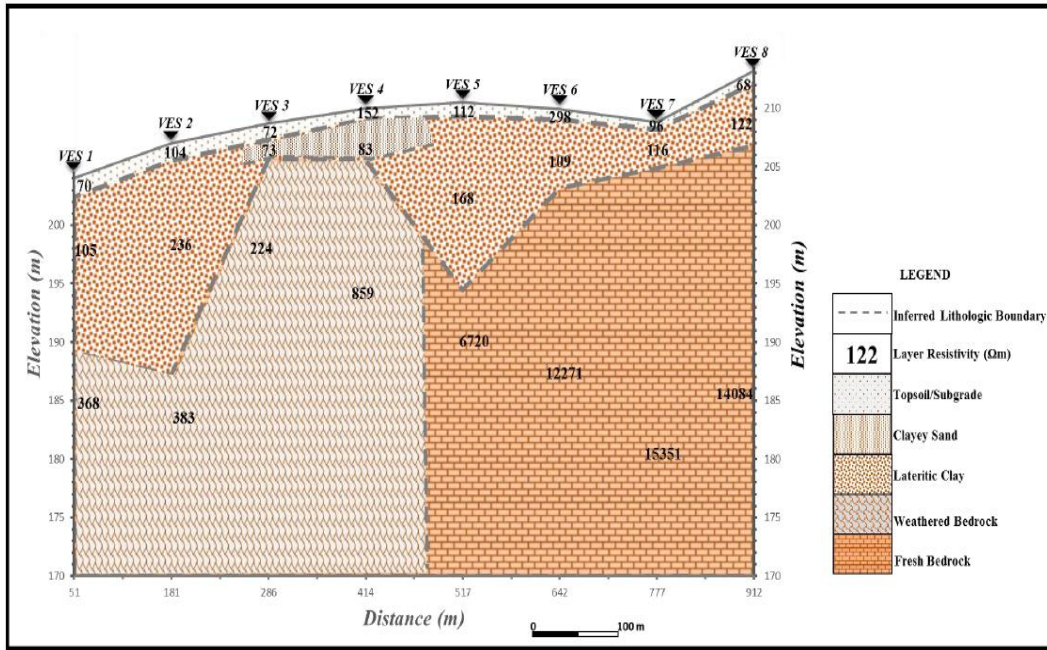
The results of the vertical electrical soundings carried out at stations 1-8 (Fig. 2) are summarized as a table of geo-electric parameters (Table 1) and geo electric section (Fig. 6). The geo-electric section presents the variation in weathering of the subsurface lithologic unit along Apete-Akufo road under study with a pictorial view of the differential weathering of the bedrock along the road section. The VES results assist to determine the overall or generalized degree of saturation of the subsurface materials at each station since water saturation indicates occurrence of fractures and voids that could suggest reduced rock stiffness. [22]. VES results show five (5) observable lithologic units in three (3) layered successions along Apete-Akufo road, the first, second and third layers which are topsoil, clayey sand or lateritic clay, and weathered bedrock or fresh bedrock respectively (Fig. 6). The resistivity of the various lithologic units ranges from: 68-238 Ω m for Topsoil, 72-236 Ω m for clayey sand or lateritic clay, 224-859 Ω m for weathered bedrock and 6720-15351 Ω m for fresh bedrock. The topsoil is regarded as the subgrade layer directly under the asphalt pavement and it is directly responsible for the stability of the road pavement. The thickness of the topsoil layer ranges from 0.6-1.6 m. The stable section of the road represented by VES station 2 presents topsoil resistivity value of 104 Ω m with thickness of 1.5 m, weathered bedrock resistivity is 236 Ω m with layer thickness of 18.3 m. The fractured bedrock has a resistivity value of 383 Ω m (Fig. 7). The average resistivity of the overburden layers at VES station 2 is 241 Ω m with overburden thickness above 19 m. VES Station 1 represents an unstable section of the road with topsoil resistivity value of 70 Ω m with thickness of 1.6 m, weathered bedrock resistivity is 105 Ω m with layer thickness of 13.3 m. The fractured bedrock has a resistivity value of 368 Ω m (Fig. 7). The overburden thickness at the VES station is in excess of 15 m with an average resistivity of 181 Ω m. The most unstable part of the road section is represented by VES station 5, which presents topsoil and weathered bedrock resistivities of 112 Ω m and 168 Ω m with corresponding thicknesses of 1.2 m and 14.8 m, respectively. The resistivity of the third layer indicated a fresh bedrock zone with resistivity of 6720 Ω m (Fig. 7). The average resistivity of the overburden at VES station 5 is 140 Ω m, with overburden thickness of about 16m.

The stability of road pavement can be inferred from the resistivity of the topsoil and the overburden lithologic units. Increase in moisture and clay content lowers the resistivity values of the overburden (tends to less than 100 Ω m), with the presence of clay and moisture suggestive of weak zones that are capable of undermining the stability of overlying road pavement [23]. It was observed that stability of road pavement along the Apete-Akufo road decreases with lower average overburden resistivity, as the lower resistivity (< 100 – 200 Ω m) is indicative of abundance of clay mineral presence [24].

Fig. 6. Geo-Electric Section Along the Studied Section of Apete-Akufo Road

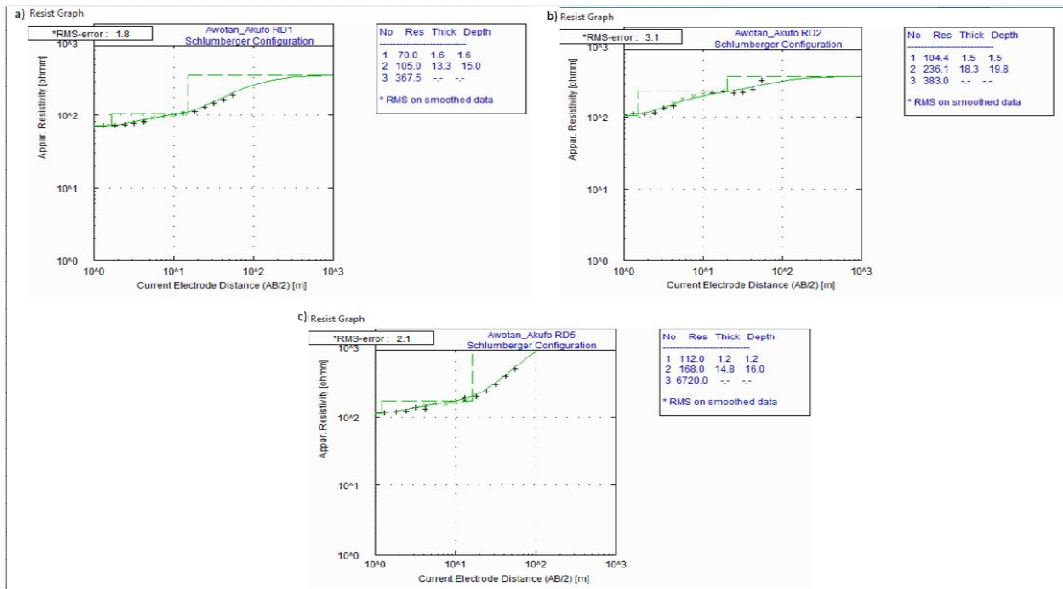
Fig. 7. VES inversion curves for (a) VES Station 1 (b) VES Station 2 and (c) VES Station 5, representing the unstable, stable and highly unstable sections of Apete-Akufo Road

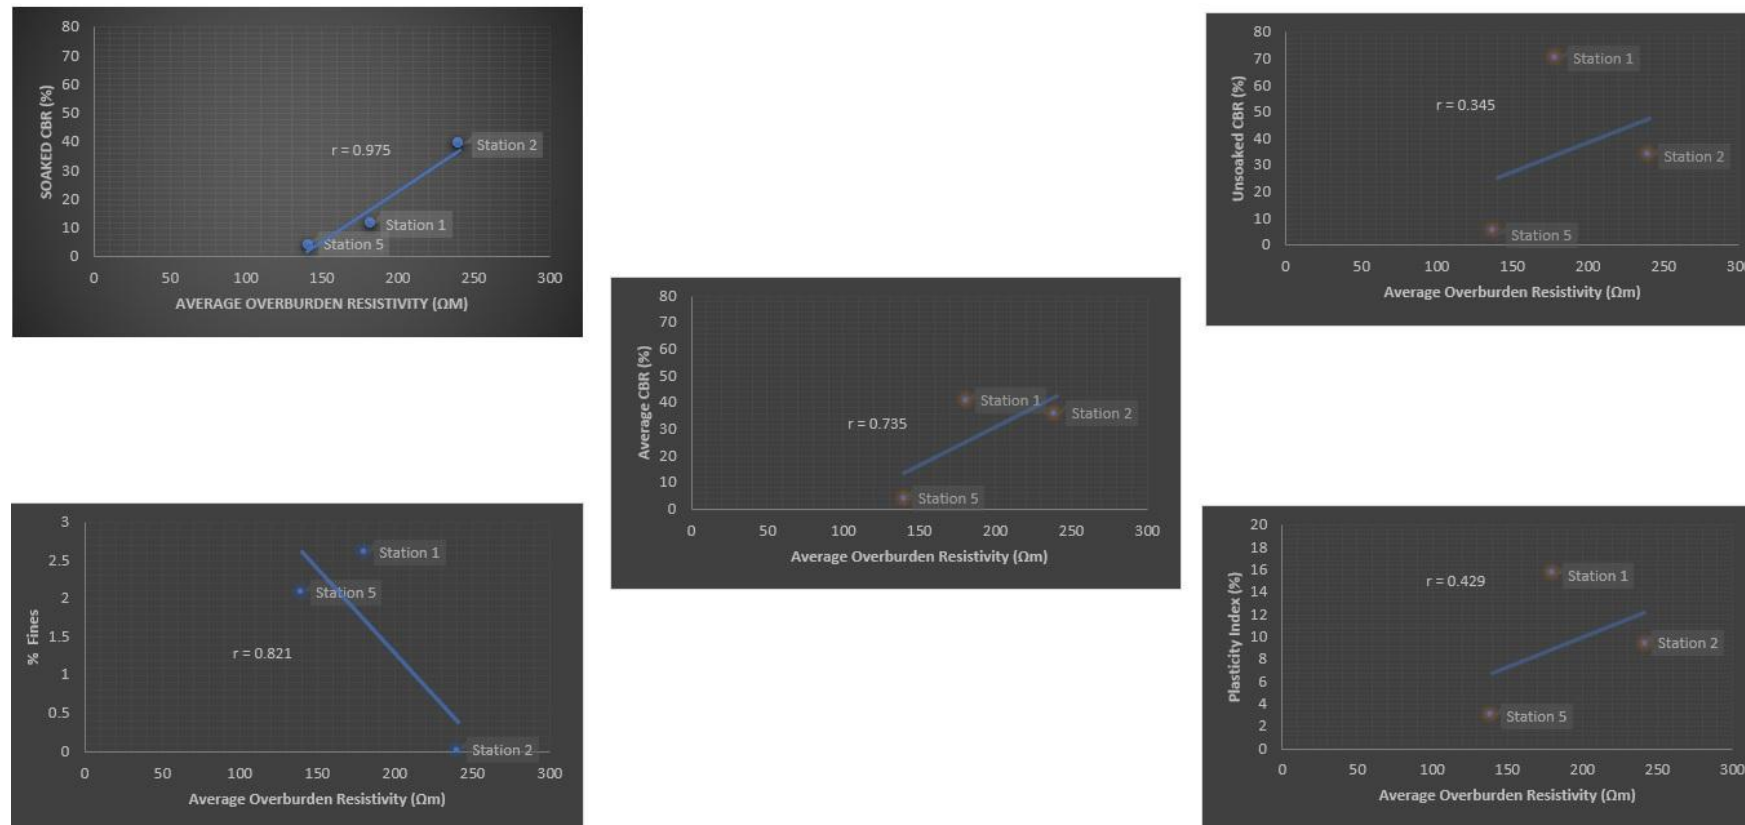
Fig. 8. Coefficient of correlation plots of results from geophysical and geotechnical studies at VES stations 1, 2 and 5 along Apete-Akufo road

The average overburden resistivity shows strong correlation ($r = 0.951$) with the soaked CBR values obtained from the studied road section, suggesting a linear relationship between subgrade material resistivity and soaked CBR values (Fig. 8). Conversely as described by Osinowo et al [27], there exist an inverse linear relationship ($r = 0.8213$) between % fine grained particles and observed subgrade material resistivity (Fig. 8). Average CBR values which is an average of both soaked and unsoaked CBR values have a weak linear relationship ($r = 0.7347$) with the average overburden resistivity (Fig.8). The relationship between the overburden resistivity and unsoaked CBR values shows very poor linear correlation ($r = 0.3448$), the same with plasticity index ($r = 0.4286$).
