Assesment of Aquifer Vulnerabilty Near a Major Dumpsite in Goshen City, Nasarawa State, Nigeria Using Integrated Geophysical Methods

Original Research Article

ABSTRACT

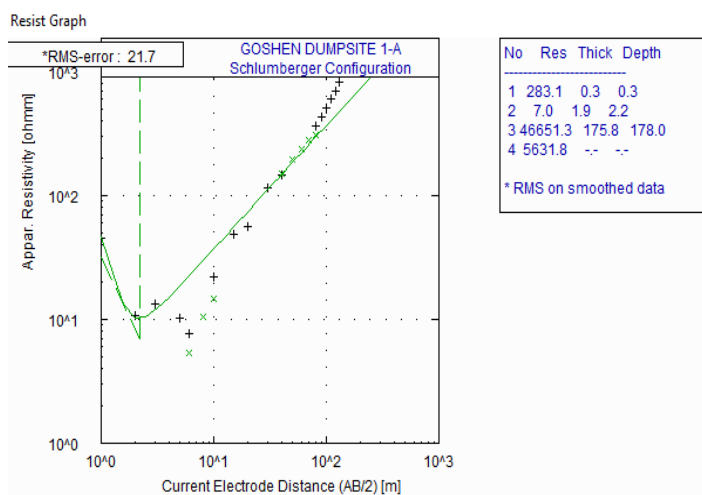
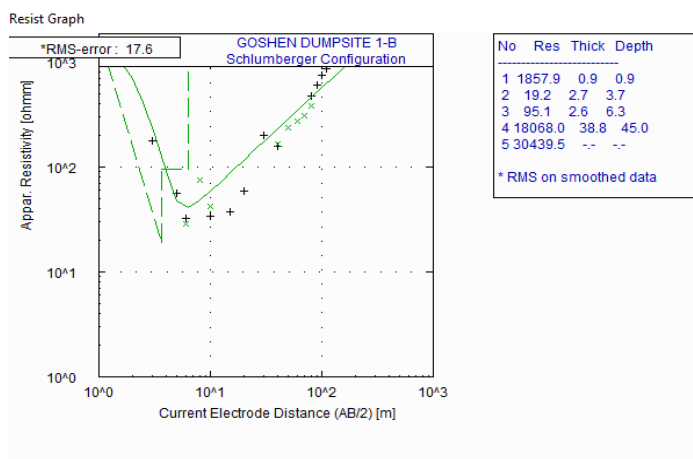
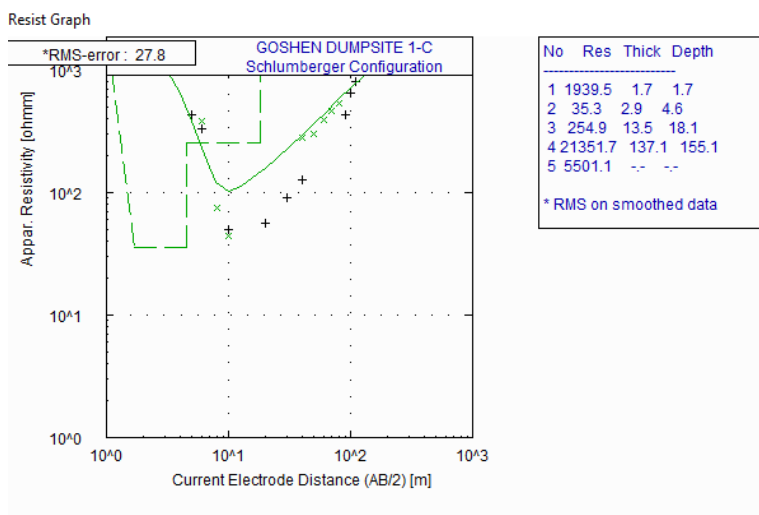
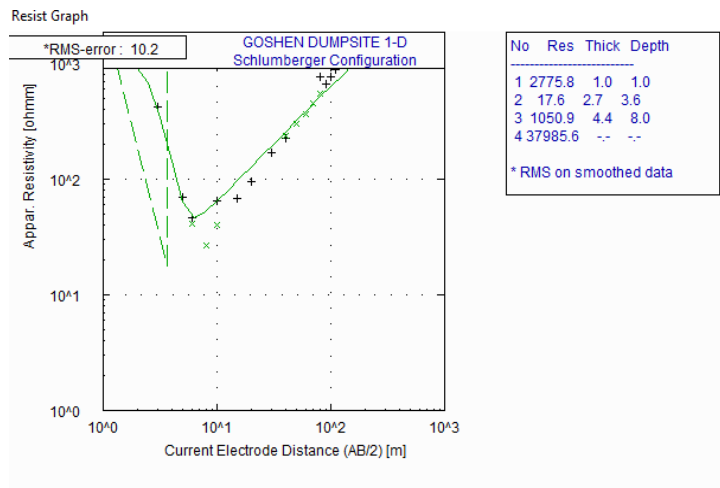
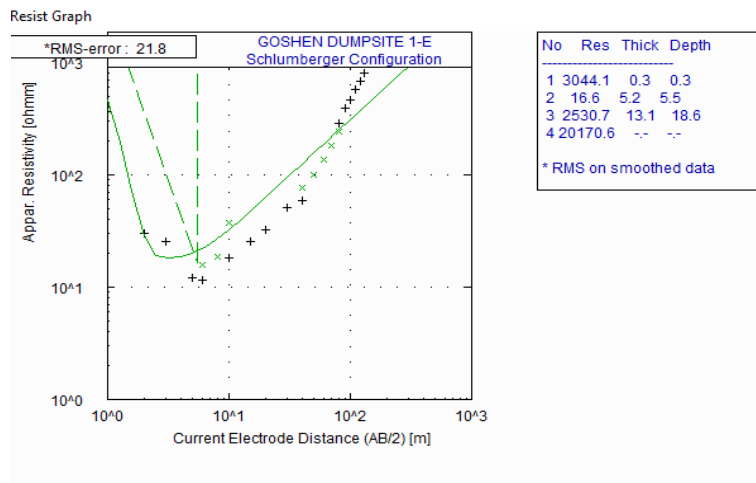
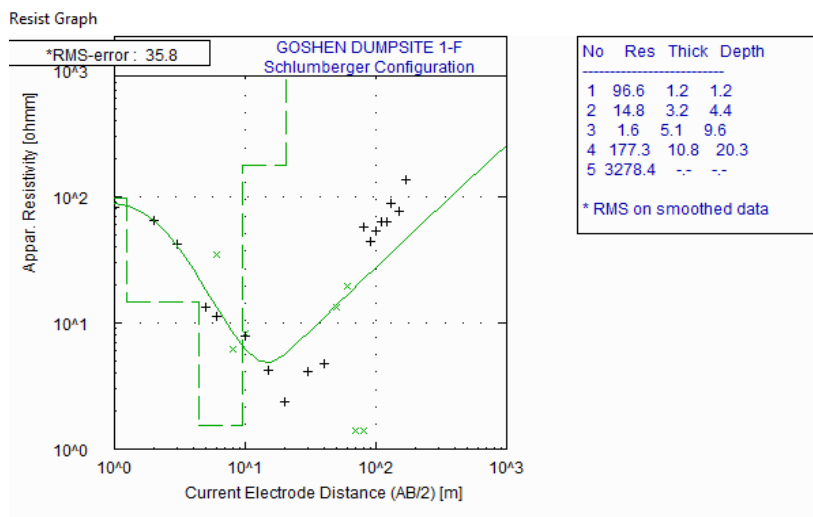
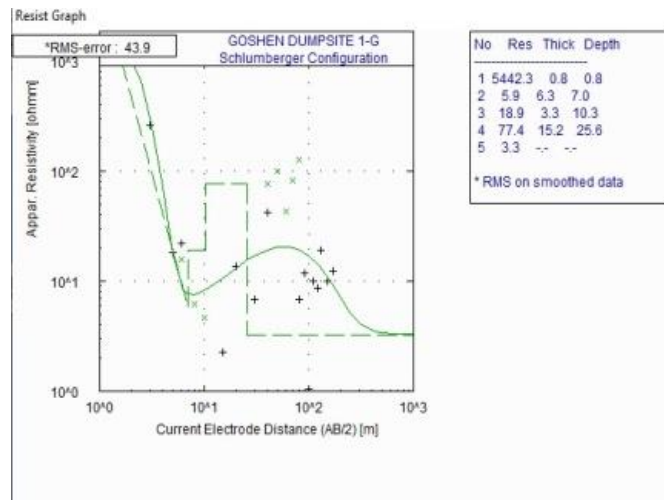
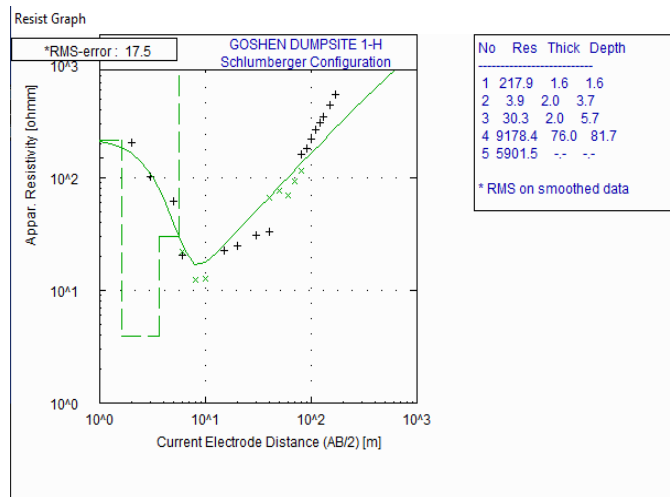
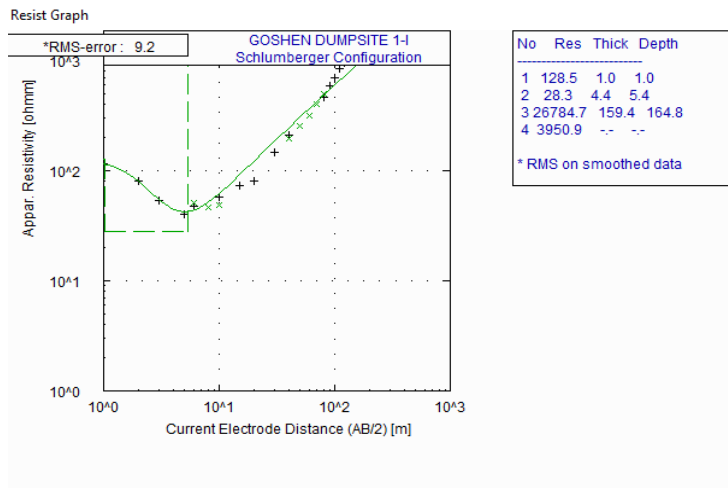
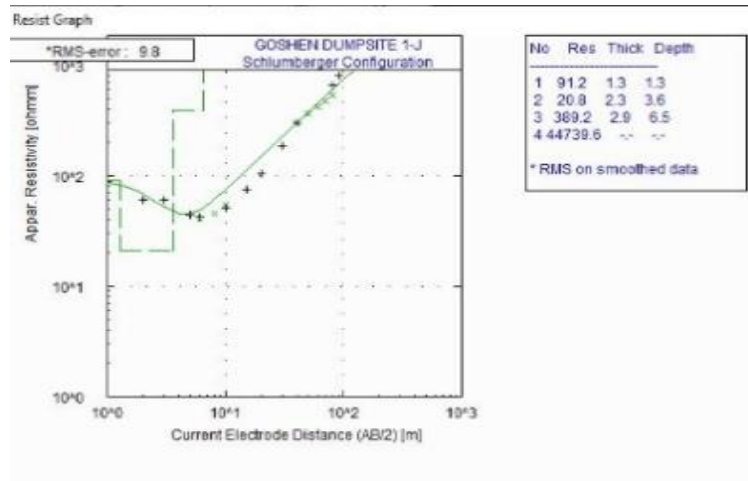
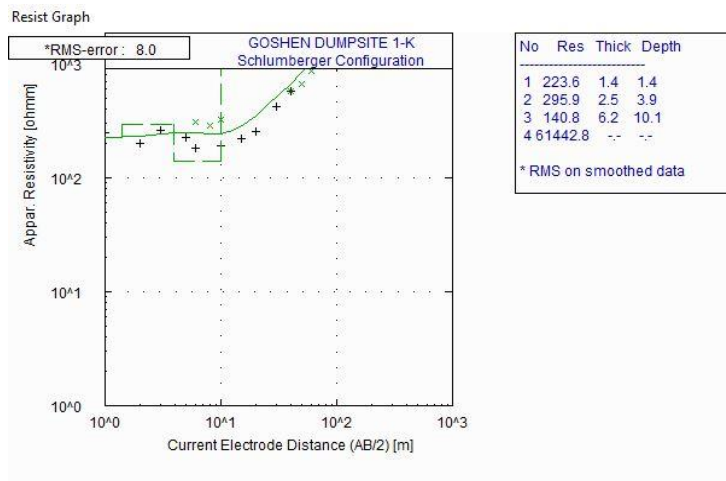
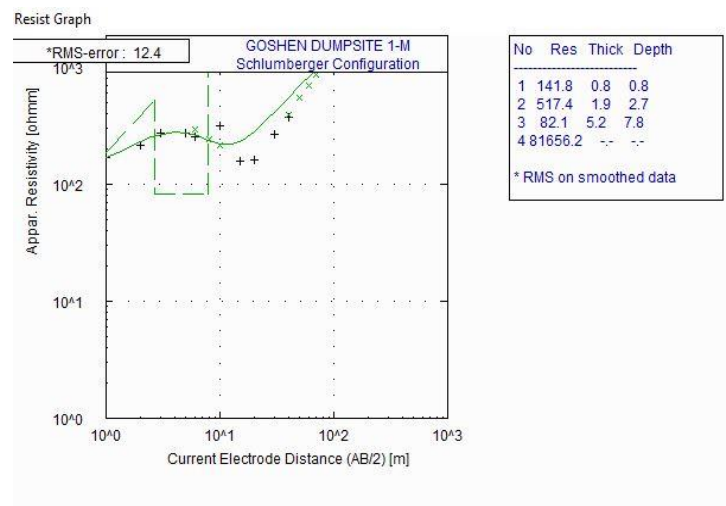
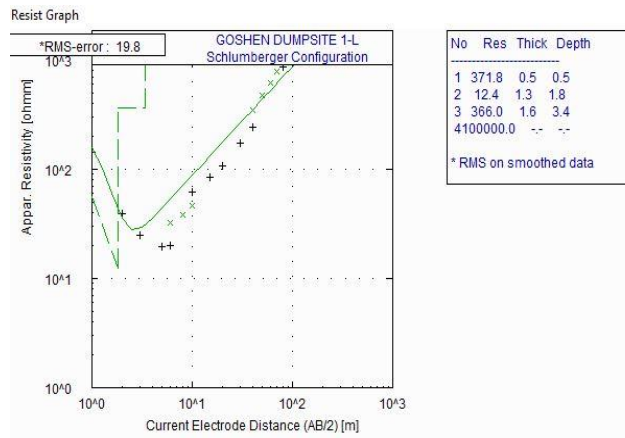
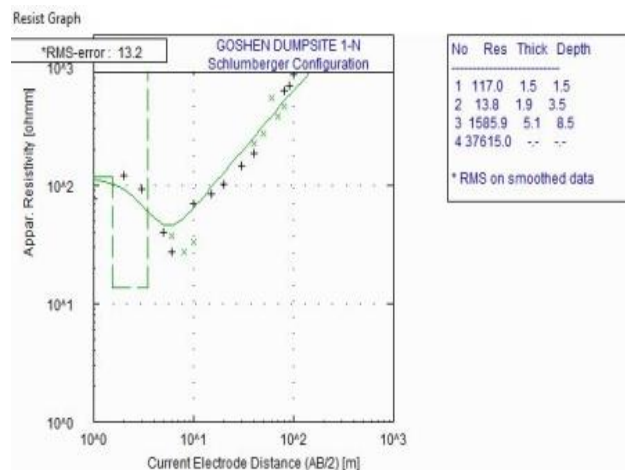
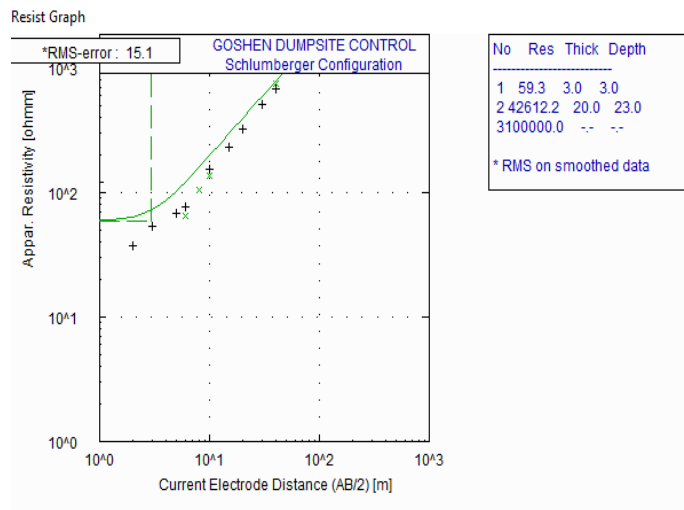
The results of the computer modeled curves for the fifteen (15) VES points conducted within Goshen dumpsite and its control centre are shown in Figs. 2 to 16.

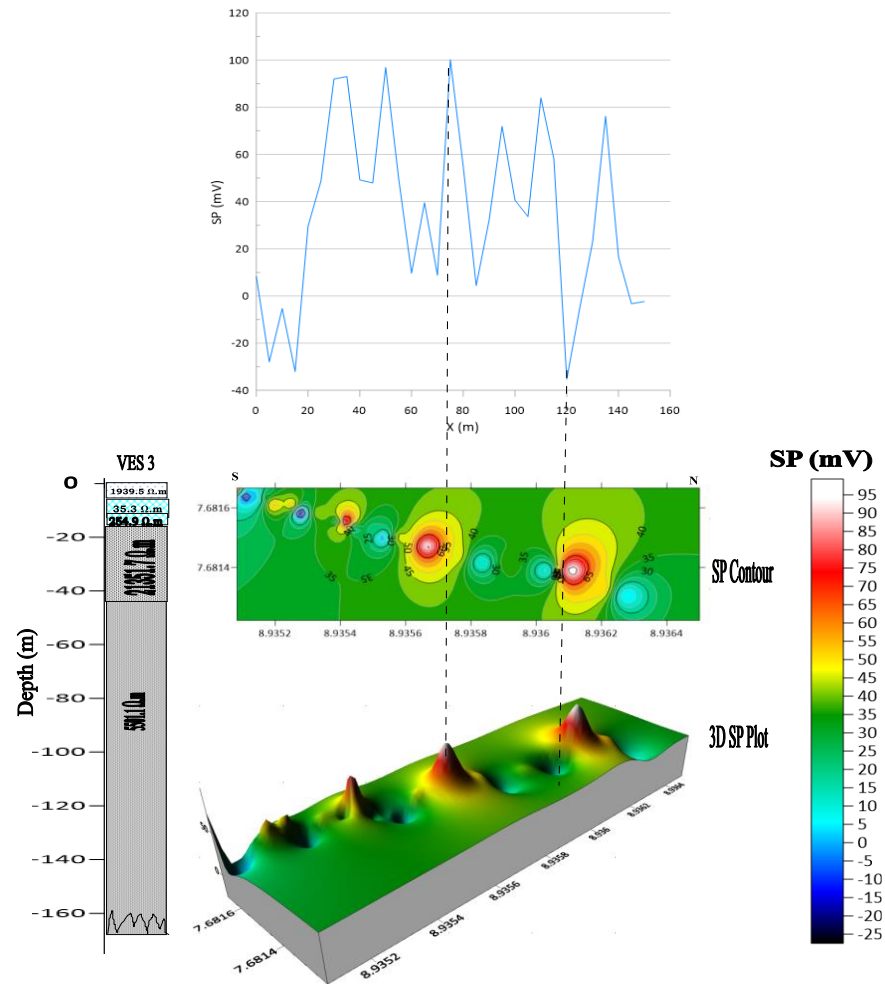
Fig. 21. Cross-section correlating the VES transverse, Self-Potential in (mV) signal, SP contours and 3-D SP plot along Profile 3

Profile 3: The cross-section (Fig. 21) correlates the VES Log, 2-D SP contours, the 3-D SP plot and SP (in mV) signals for profile 3 running in the South – North direction. The self-potential

profile in this cross-section shows variation of positive and negative SP values ranging from (-25 to 95 mV). However, the material with dominant negative SP values ranging from (-25 to -10 mV) which peaked between (0 to 20 m) and (110 and 120 m) is attributed to electrochemical reaction from groundwater flowing in the S-N direction. This result was correlated by materials with resistivity values of (35.3 Ω .m, at depth \geq 4.6 m) occurring along the VES transverse, suggestive of groundwater occurrence. The positive SP anomaly ranging from (40 to 95 mV) at points (55 and 75 m) along the profile is characteristic of quartz veins.

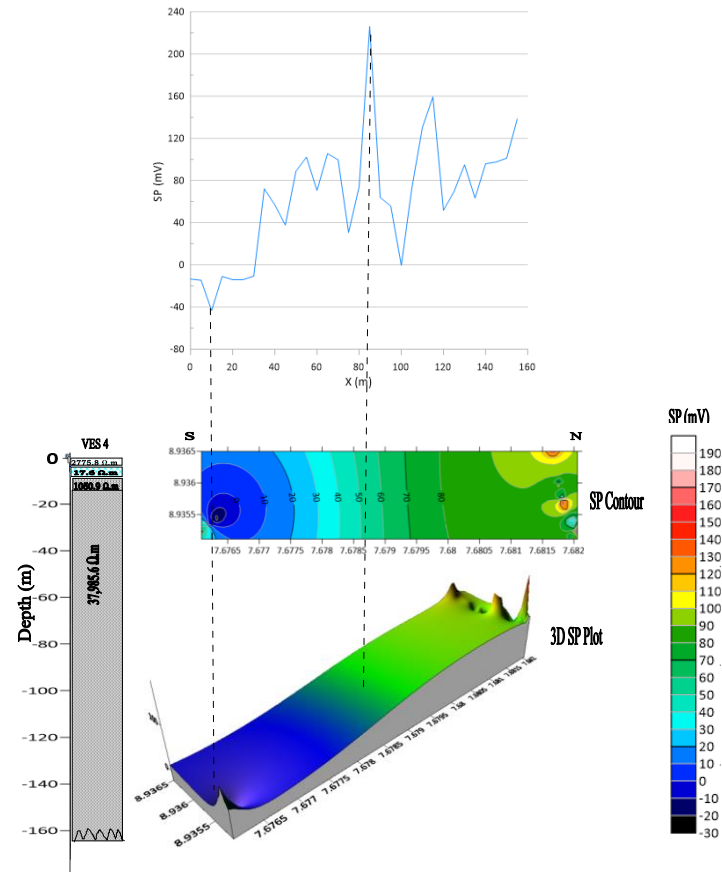
Fig. 22. Cross-section correlating the VES transverse, Self-Potential in (mV) signal, SP contours and 3-D SP plot along Profile 4

Profile 4: The cross-section (Fig. 22) correlates the VES Log, 2-D SP contours, the 3-D SP plot and SP (in mV) signals for profile 4. It indicates

variation of positive and negative SP values ranging from (-41 to 220 mV). From the southern flank, (0 to 40 m) are objects dominated by (-30 to -10 mV) negative SP values attributed to electro-kinetic processes occasioned by leachate plume from the dumpsite running in the North – South direction. This was correlated by VES log 4 indicating materials with the low resistivity values of (17.6 Ω .m, at depth \geq 3.6 m) observed beneath the topsoil along the profile.

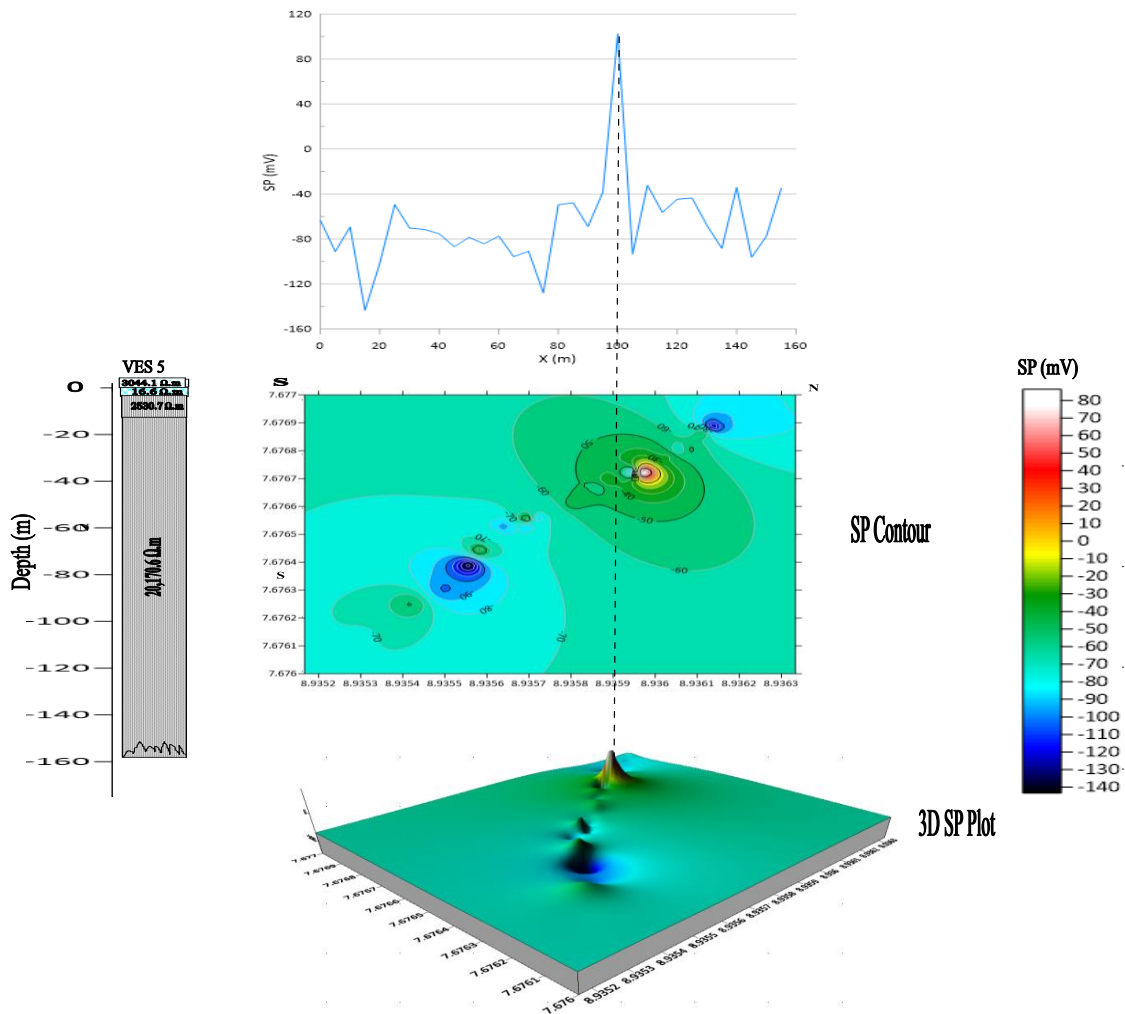
Fig. 23. Cross-section correlating the VES transverse, Self-Potential in (mV) signal, SP contours and 3-D SP plot along Profile 5

Profile 5: The cross-section (Fig. 23) correlates the SP (in mV) profile, VES Log, 2-D SP contours, the 3-D SP plot for profile 5. It shows the variation of positive and negative SP values ranging from (-140 to 90 mV). The undulating variation of the negative SP anomalies ranging

from (-140 to -10 mV) peaked at points located between (15 to 20 m, 75 to 80 m and 130 to 145 m) and it is attributed to leachate infiltration flowing in the N-S direction, along the survey line. This was correlated by the VES log 5 showing materials with low resistivity values of (16.6 $\Omega.m$, at depth ≥ 5.5 m) along the VES transverse, suggestive of leachate infiltrated zone.

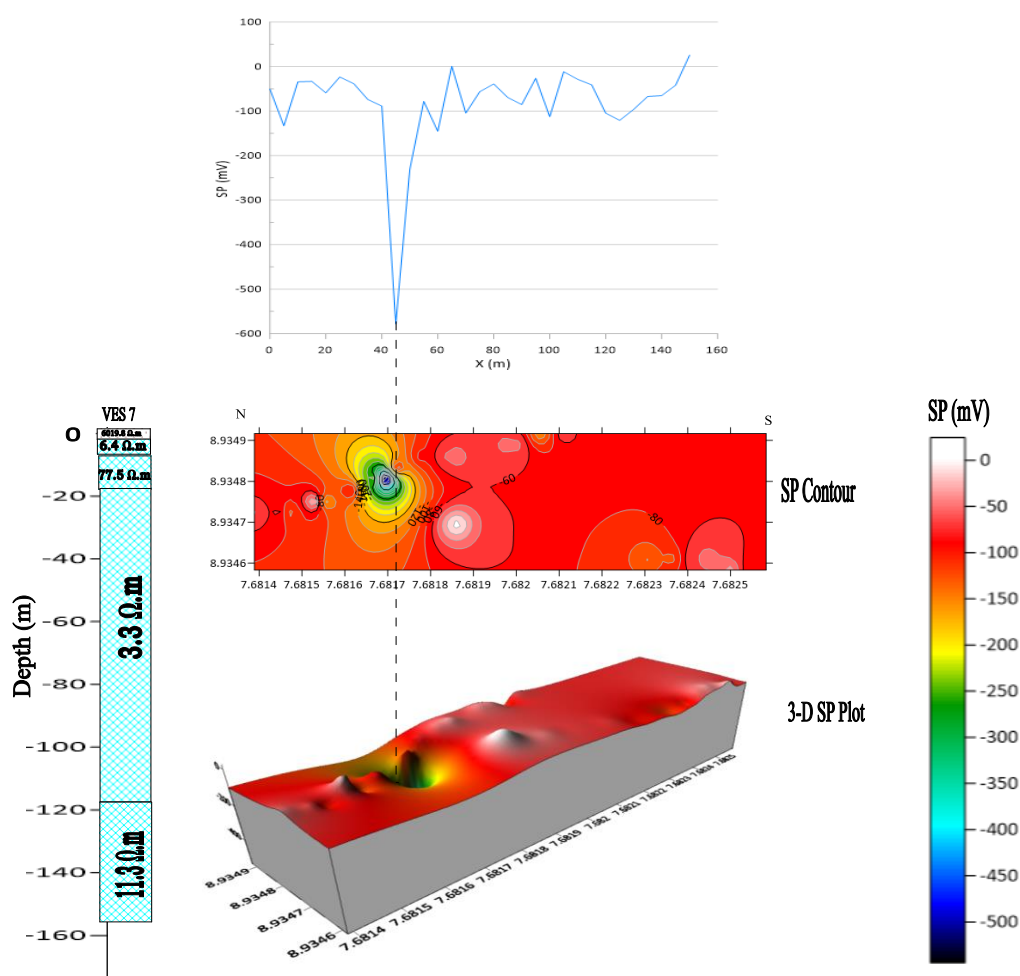
Fig. 25. Cross-section correlating the VES transverse, Self-Potential in (mV) signal, SP contours and 3-D SP plot along Profile 7

Profile 7: The cross-section (Fig. 25) correlates the SP (in mV) profile, SP contours, the 3-D SP plot and the VES log for profile 7. The self-potential values for profile 7 shows dominant negative SP values ranging from (-550 to 0.2 mV) along the entire profile line spanning from (0 to 160 m) in N - S direction. The negative SP

values peaked at (-560 mV) between (30 to 40 m) attributed to leachate infiltration into a fault/fractured layer. This was correlated by the VES log is characterized by materials beneath the topsoil; with low resistivity value of (6.4 Ω.m, at depth ≥ 8.5 m). The second layer is characterized by a material with resistivity value of (77.5 Ω.m, at depths ≥ 23.4 m) interpreted as weathered layer. Beyond this layer are materials with very low resistivity values ranging from (3.3 to 11.3 Ω.m, at depths ≥ 123.4 m) suggestive of leachate infiltrated zone. This profile is interpreted as the most leachate impacted zone within the entire study area. It has been determined that groundwater resources in the area are likely contaminated due to the depth and extent of leachate migration into the subsurface.

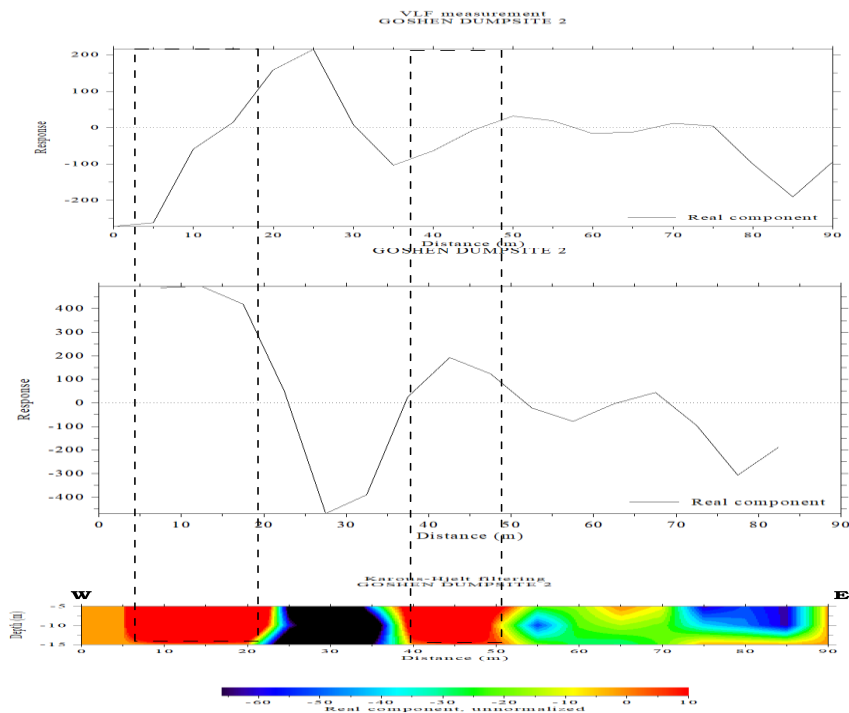
Fig. 30. Cross-section of Fraser Filtered, measured VLF and K-H pseudo section along Transverse 2

Transverse 2: The high positive anomaly ranging from (5 to 10%) along (8 to 20 m, and 40 to 50 m depths ≥ 15 m) along Transverse 2 in the W – E direction is interpreted as the migration of leachate contaminant into the subsurface. Between (20 to 40 m, at depths ≥ 15 m) is a black material with negative anomaly ranging from (-50 to -60 %), suggestive of pegmatites veins which outcrops the area. At points between (50 to 90 m, at depths ≥ 14 m), are intercalations of greenish, bluish and lemon coloured materials suggestive of rock intrusions. The anomalous conductive zones are suspected to be lineament structures while the resistive features are presumed to be weathered bedrock.
