Geophysical and Geotechnical Investigation of Road Pavement Failure in Part of Ibadan Metropolis Southwestern Nigeria

Case Study

Road pavement failure observed along a section of Apete-Akufo Major Road in Ibadan metropolis southwestern Nigeria, necessitates the need to ascertain whether the failure results from poor construction practices or poor engineering properties of subgrade materials. Geophysical and geotechnical survey results were compared to investigate the cause of the road pavement failure. Vertical Electrical Sounding (VES) with geotechnical study which include; grain size analysis, Atterberg limits and California Bearing Ratio (CBR) tests, were carried out on disturbed subgrade samples obtained between 0 – 1 m depth from VES Stations 1, 2 and 5, corresponding to unstable, stable and highly unstable sections of the road respectively. The quality of the subgrade was evaluated based on Atterberg limits, layer resistivity and CBR values. Eight (8) VES stations established 100m apart along the road section delineated 5 lithology; topsoil, clayey sand/lateritic clay, weathered bedrock and fresh bedrock with resistivity range of 68-238Ωm, 72-236Ωm, 224-859Ωm and 6720-15351

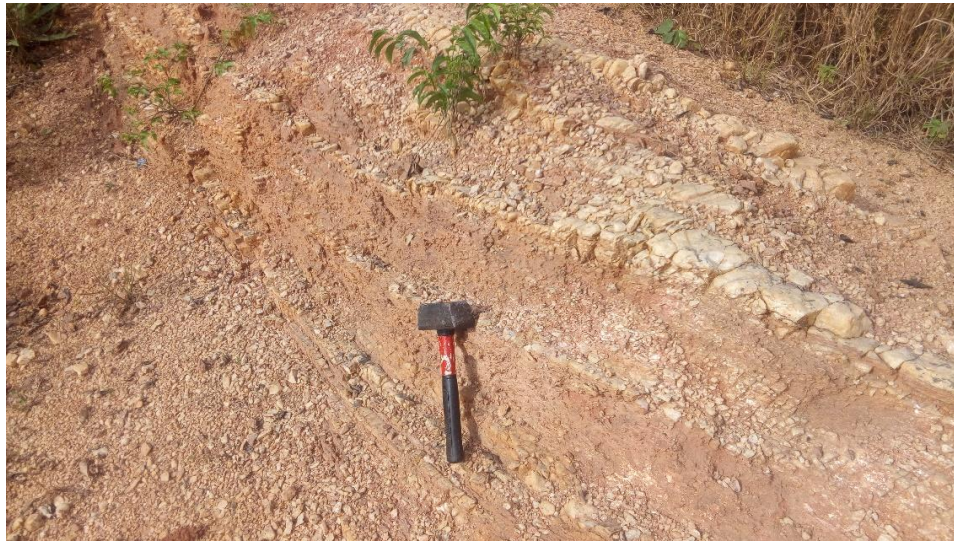
The study area is underlain by quartzite and quartz schist which are part of the basement complex geology of southwestern Nigeria [9]. The lithologic units were observed along the Apete-Akufo road as outcrops striking NW-SE with an average dip of 70° East (Fig. 3).

Fig. 3. Quartz-Schist outcrop along Apete-Akufo road section

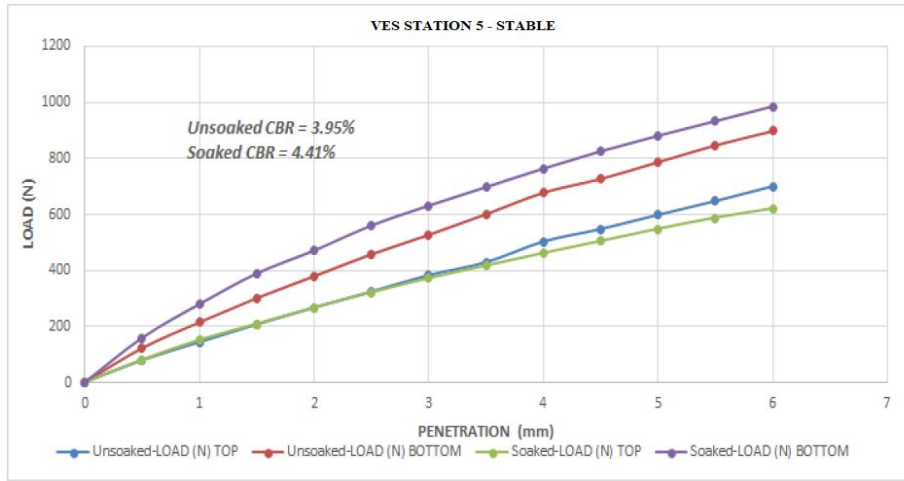
CBR Result for VES Station 5

Station 2 shows that the subgrade is stable when wet or dry with relatively similar soaked and unsoaked CBR values. Samples from the failed section in VES Station 5 has soaked and unsoaked CBR values well below acceptable standards and this can be said to be responsible for the failure of the road section.

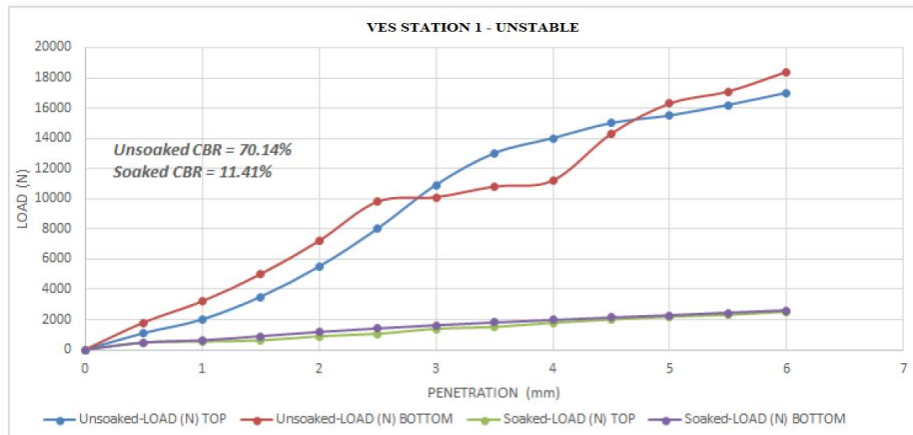
CBR Result for VES Station 1

Also, CBR results samples from VES Station 1 with soaked and unsoaked CBR of 11.41% and 70.14% respectively, indicate that the subgrade is fairly stable especially when the road is dry and its stability reduces with wetness. Hence the road pavement in this section failed due to poor drainage as observed on site. Samples from VES

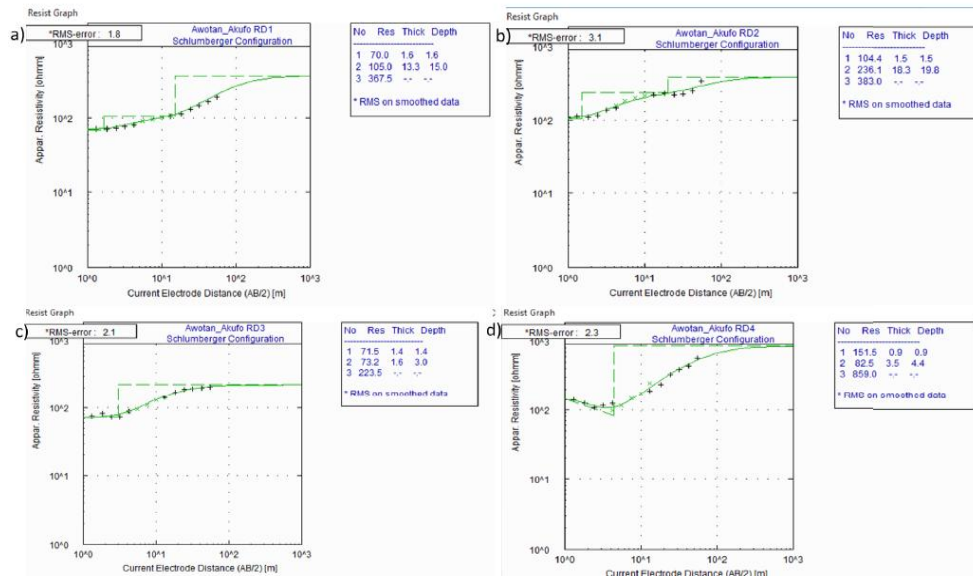
Vertical Electrical Sounding Inversion Curves for VES Stations in (a) VES Station 1 (b) VES Station 2 (c) VES Station 3 (d) VES Station 4 Along Apete-Akufo Road

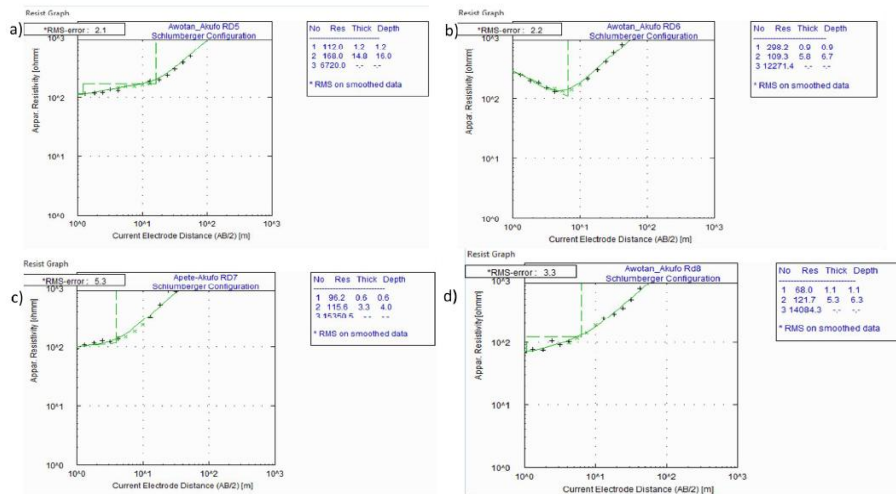
The results of the vertical electrical soundings carried out at stations 1-8 (Fig. 2) are summarized as a table of geo-electric parameters (Table 1) and geo electric section (Fig. 6). The geo-electric section presents the variation in weathering of the subsurface lithologic unit along Apete-Akufo road under study with a pictorial view of the differential weathering of the bedrock along the road section. The VES results assist to determine the overall or generalized degree of saturation of the subsurface materials at each station since water saturation indicates occurrence of fractures and voids that could suggest reduced rock stiffness. [22]. VES results show five (5) observable lithologic units in three (3) layered successions along Apete-Akufo road, the first, second and third layers which are topsoil, clayey sand or lateritic clay, and weathered bedrock or fresh bedrock respectively (Fig. 6). The resistivity of the various lithologic units ranges from: 68-238 Ω m for Topsoil, 72-236 Ω m for clayey sand or lateritic clay, 224-859 Ω m for weathered bedrock and 6720-15351 Ω m for fresh bedrock. The topsoil is regarded as the subgrade layer directly under the asphalt pavement and it is directly responsible for the stability of the road pavement. The thickness of the topsoil layer ranges from 0.6-1.6 m. The stable section of the road represented by VES station 2 presents topsoil resistivity value of 104 Ω m with thickness of 1.5 m, weathered bedrock resistivity is 236 Ω m with layer thickness of 18.3 m. The fractured bedrock has a resistivity value of 383 Ω m (Fig. 7). The average resistivity of the overburden layers at VES station 2 is 241 Ω m with overburden thickness above 19 m. VES Station 1 represents an unstable section of the road with topsoil resistivity value of 70 Ω m with thickness of 1.6 m, weathered bedrock resistivity is 105 Ω m with layer thickness of 13.3 m. The fractured bedrock has a resistivity value of 368 Ω m (Fig. 7). The overburden thickness at the VES station is in excess of 15 m with an average resistivity of 181 Ω m. The most unstable part of the road section is represented by VES station 5, which presents topsoil and weathered bedrock resistivities of 112 Ω m and 168 Ω m with corresponding thicknesses of 1.2 m and 14.8 m, respectively. The resistivity of the third layer indicated a fresh bedrock zone with resistivity of 6720 Ω m (Fig. 7). The average resistivity of the overburden at VES station 5 is 140 Ω m, with overburden thickness of about 16m.

Vertical Electrical Sounding Inversion Curves for VES Stations in (a) VES Station 5 (b) VES Station 6 (c) VES Station 7 (d) VES Station 8 Along Apete-Akufo Road
