Corrosion Behavior of Welded Joints of X70 Pipeline Steel Produced by High-frequency Welding

Original Research Article

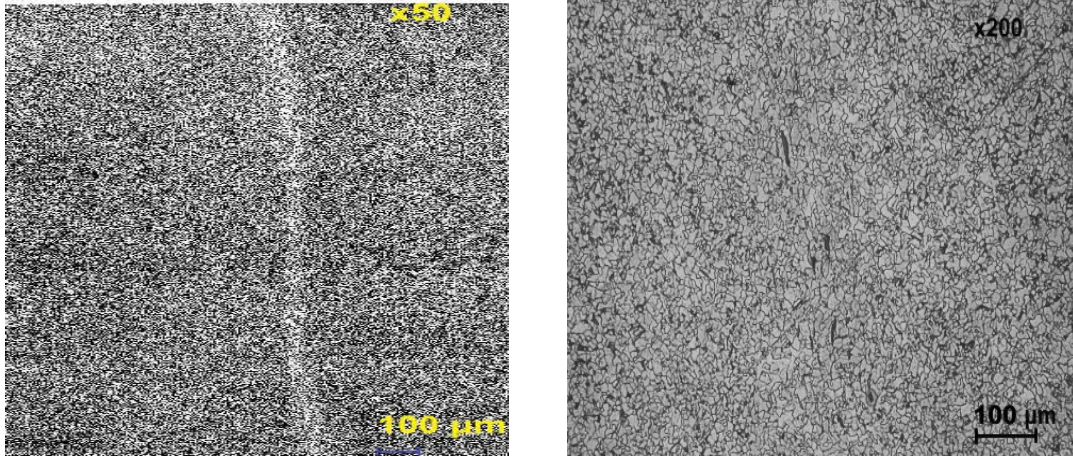
Fig. 1. Microstructure of the fusion zone of the HFW-pipe welded joint Ø508.0 × 8.7 mm from steel category X70 after etching in the natal

The microstructure of the fusion zone of the HFW-pipe $\varnothing 508.0 \times 8.7$ mm from steel of category X70 is shown in Fig. 1. The fusion line represents a distinct continuous carbon-free light band. Due to the local thermal treatment of coarse-grained lamellar or needle structure that formed after welding in the zone of thermal influence, transforms into fine-grained ferrite-perlite. The amount of perlite component in the

structure is determined by the carbon content of the steel.

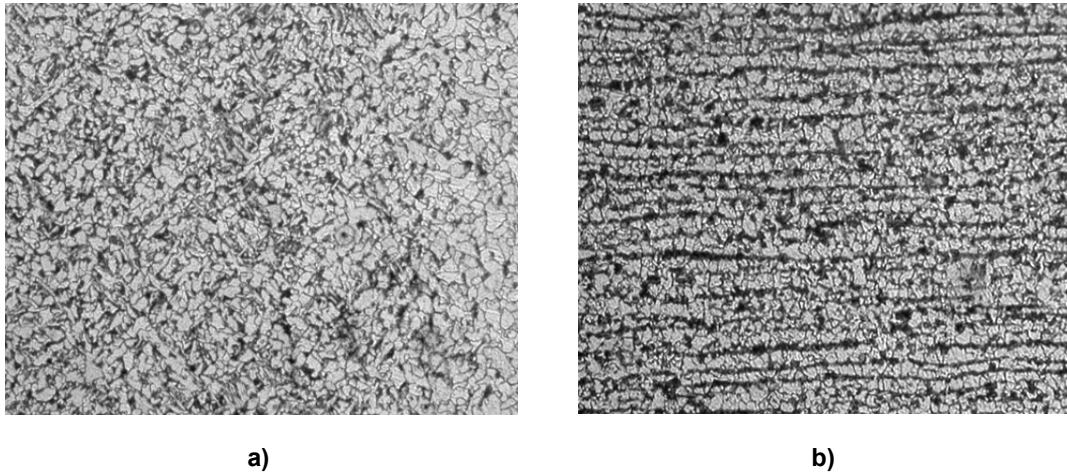
Fig. 2. Microstructure of the base metal of the HFW-pipe Ø508,0 × 8,7 mm from steel category X70, heat affected zone (a) and base metal (b) after etching in 4% nital, × 200

The microstructure of the base metal and the heat affected zone of the pipe is a fine-grained ferrite-perlite mixture with enough highlighted strips (Fig. 2).

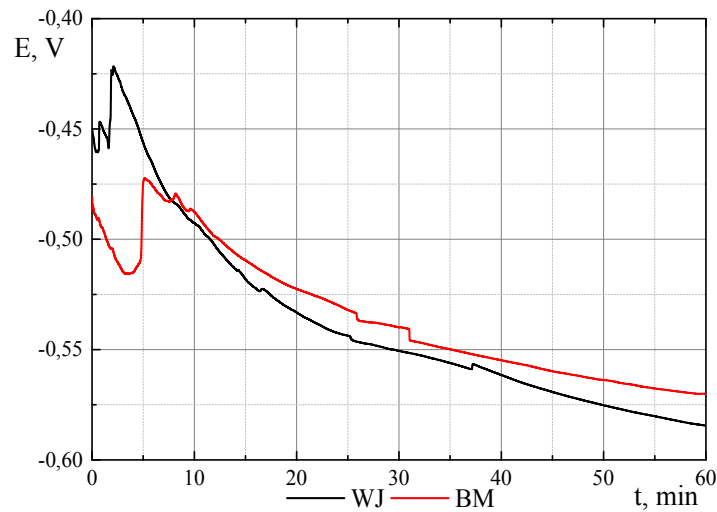
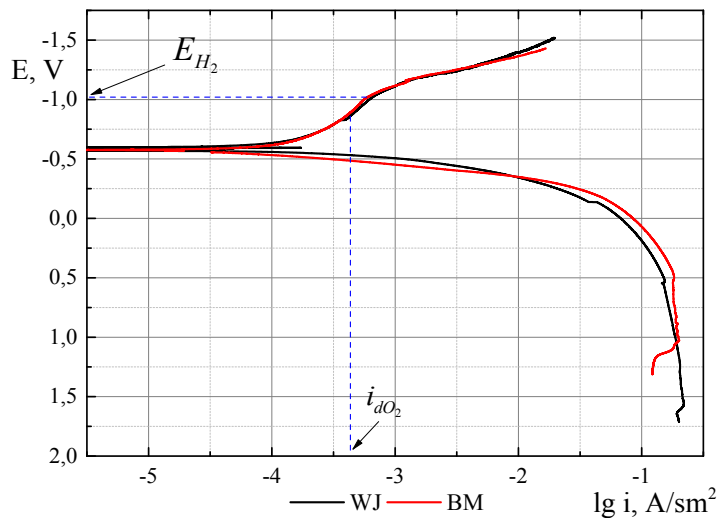
Fig. 3. Changes in corrosion potential in time (a) and the polarization curves (b) bm and wj of the sample of the hfw-pipe in solution no 1

Figs. 3, 4 and 5 shows the dynamics of changes in the corrosion potential (a) and the polarization curves (b) of the base metal (BM) and the welding joint (WJ) of the HFW-pipe in solutions No 1, No 2 and No 3, respectively. As can be seen from the curves presented Fig. 3a, the corrosion potentials on BM and WJ are close in value and are -0.570 V and -0.584 V respectively. The behavior of the anode and cathode curves of the two welded zones is similar Fig. 3b. The numerical values of the electrochemical parameters of the cathode and anode processes, that was determined graphically from Fig. 3b, is shown in Table 2. From the corrosion potential up to 0.5 V for both zones in this solution, is characterized a wide area of active dissolution. There is a slightly smaller angle of the Tafel slope of the starting zone of the anode curve of WJ zone in comparison the BM, which indicates a higher rate of anode dissolution under the same conditions. For potentials larger than -0.25 V, the deceleration of the anode dissolution was observed due to passivation of the surface of the sample.

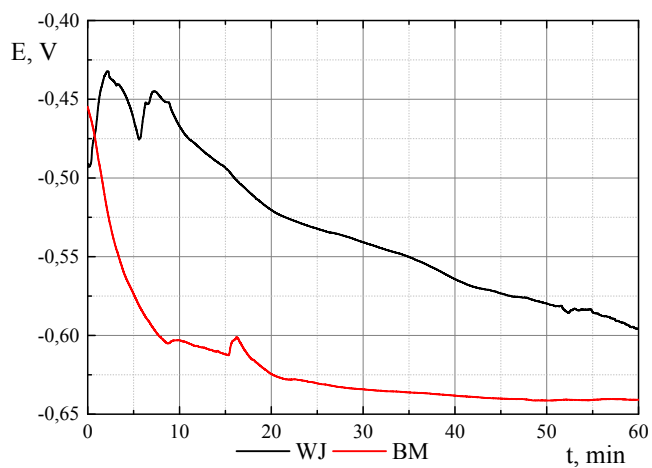
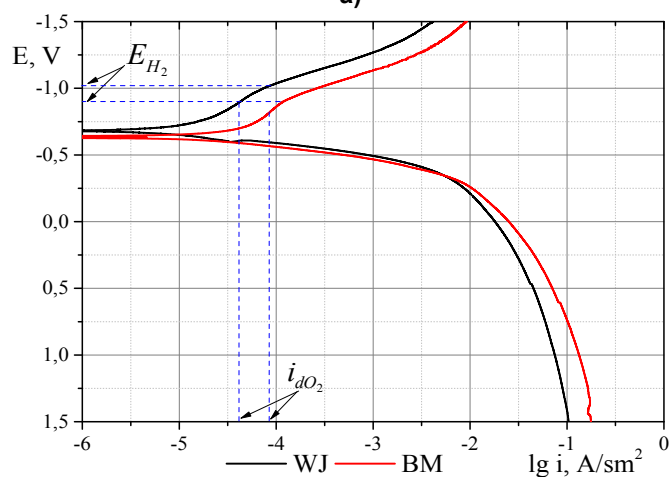
Fig. 4. Changes in corrosion potential in time (a) and the polarization curves (b) of the BM and the WJ of the sample of the HFW-pipe in solution no 2

In the solution No 2, BM is characterized by a sharp shift of the corrosion potential in the region of negative values from -0.455 V that stabilizes after 60 minutes at -0.641 V, and on the WJ were shifted smoothly from -0.490 V, and stabilizes at -0.596 V, Fig. 4a. This difference in potentials is significant, but considering the much smaller area of the WJ as compared to the BM, it does not pose any danger in terms of the development of local corrosion processes. The area of active dissolution is long enough for both zones - from the potential of corrosion to the potential is about -0.25 V, above which there is a slowing down of the anode process due to the surface shielding by products of corrosion. The Tafel's angles of slope of the initial regions of the anode curves indicate a higher rate of dissolution of the BM in comparison with the WJ.

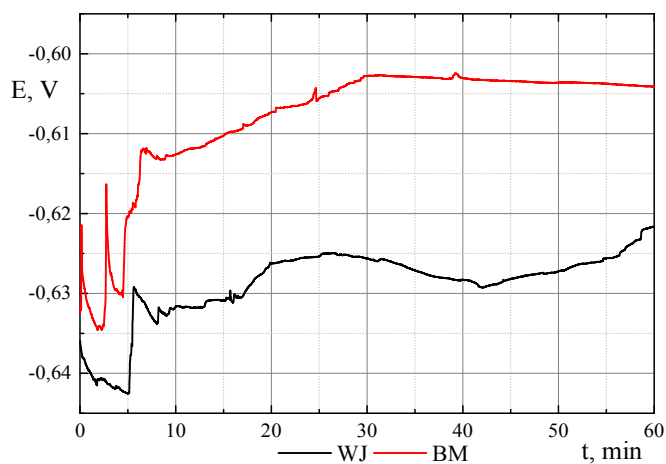
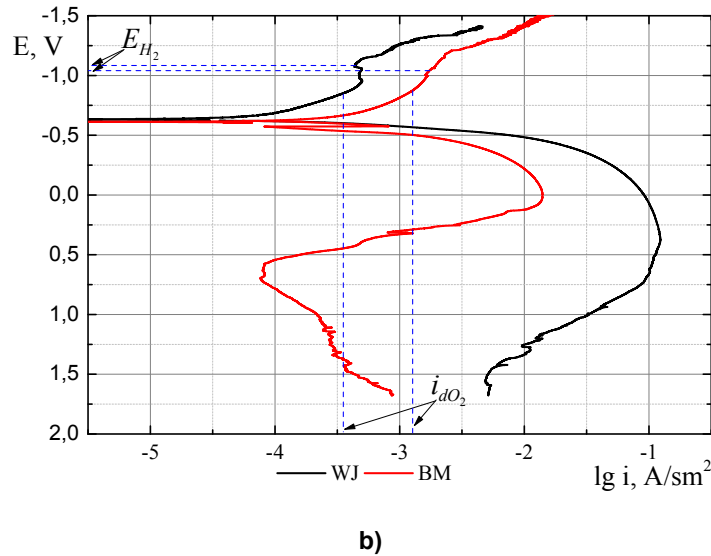
Fig. 5. Changes in corrosion potential in time (a) and polarization curves (b) of the bm and the wj of the sample of the hfw-pipe in solution no 3

In solution № 3, the dynamics of the change in corrosion potentials within 60 minutes is characterized by a slight displacement in the region of positive values for both the BM and the WJ, varying from -0.632 V up to -0.604 V and -0.636 V up to -0.622 V, respectively. The electrochemical characteristics of the anode and cathode processes on the BM and the WJ are shown in Table 2. The analysis of the course of the anode curves shows that the rate of dissolution of the WJ at the potential -0.5 V is almost 6 times higher than the BM (Table 2). Both zones are characterized by the area of active dissolution: for the BM in the range from -0.543 to -0.03 V; for the WJ – from -0.588 to 0.25 V.
